Goodell Pratt Eggbeater Drill

June 2016

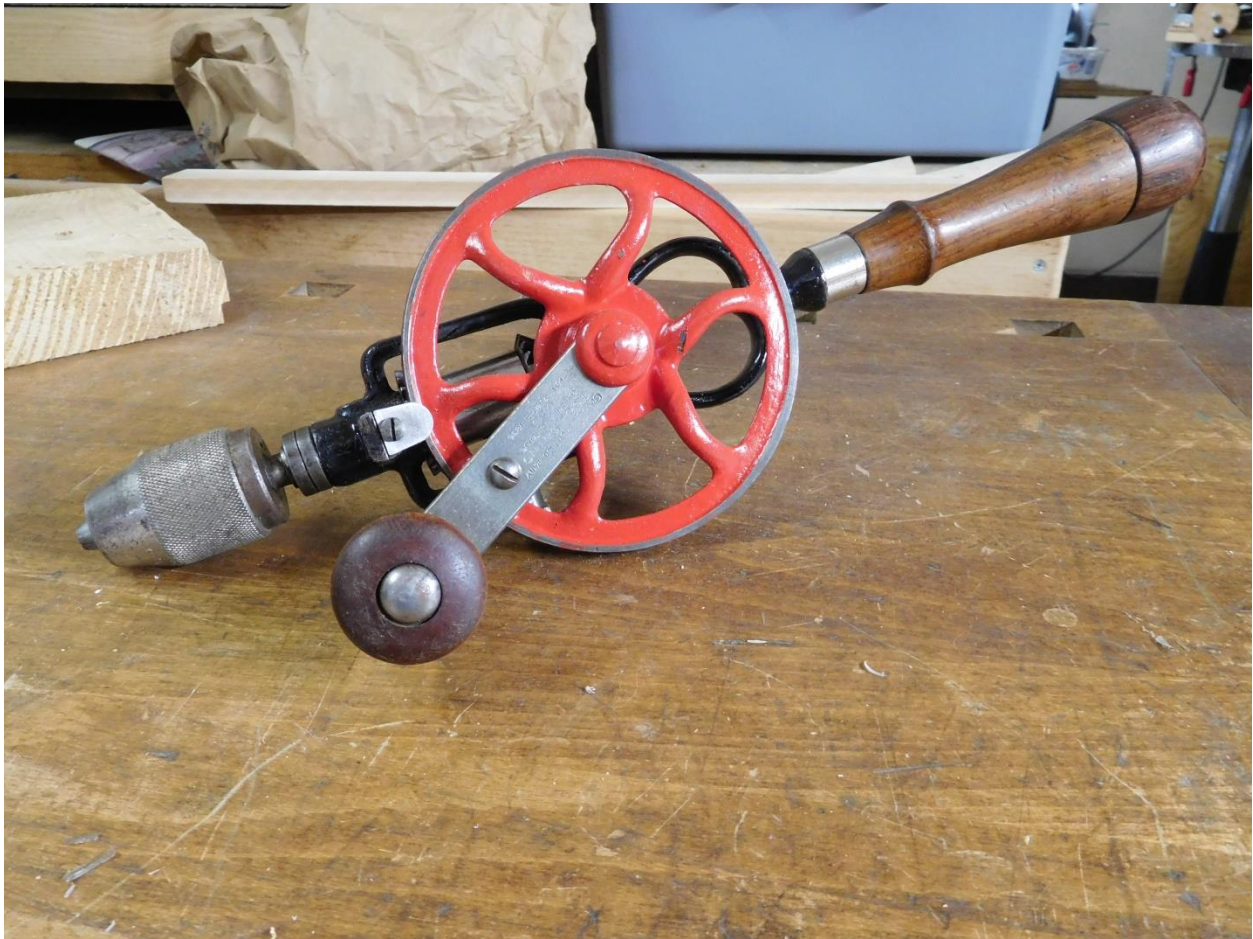
Cordless drills have been popular for a long time. Of course, the originals were powered by the user. Today, these eggbeater drills are popular among old tool collectors. They are found in various states of repair and sometimes need a tune up. That was the case of the Goodell Pratt drill that serves as eye candy in my shop.

These tools are complicated machinery and often need cleaning and minor adjustments to keep in their top working form. Often a damage part will render the tool useless. They were made to be user serviceable and simple repairs are often very easy to do. When I inspected this drill, it was hard to turn and the chuck was sluggish. The three leaflets did not move in unison and even required some coaxing to move at all. I began by adding oil to the oil holes to lubricate the bearings.

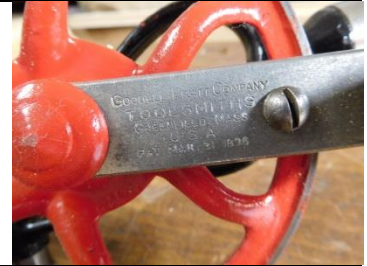
The patent date on the hand crank is "March 31, 1896". It is in very good condition for its age. The handle is rosewood with a screw off cap for drill bit storage. The paint is in good and original condition. Most of the plating is intact and in good condition.

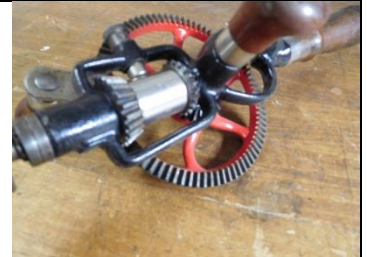
Here is a picture of the reverse side. The drill has oil cups for lubrication. Once oiled, all parts move quite freely.

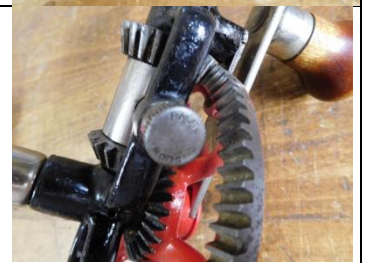
It has a transmission of sorts with two gear settings for increasing torque.

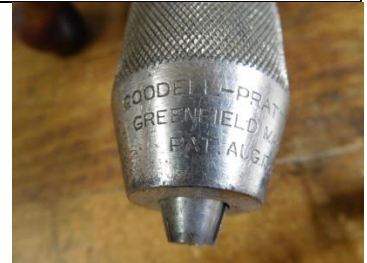
The chuck is patented "August xx xxxx". It works but needs attention because it is sluggish.

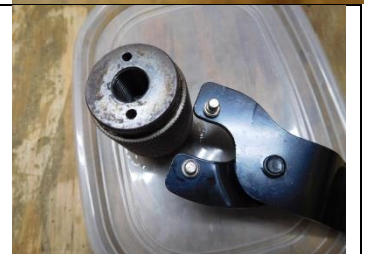
When the chuck is unscrewed from the body, two holes are revealed. A spanner wrench is required for disassembly. Unfortunately, my spanner pins are too large. I could file them down but that will take time. I think it is time to make a servicing tool.

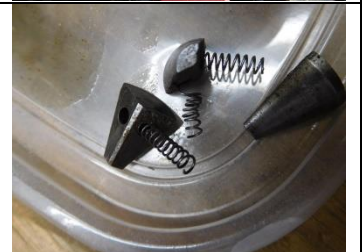
Here are the goodies from inside. There are three leaflets that look like heart valve leaflets which are held together by small springs. These leaflets are hardened steel and grip the bit when they are tightened. The springs help them stay together and act in unison.

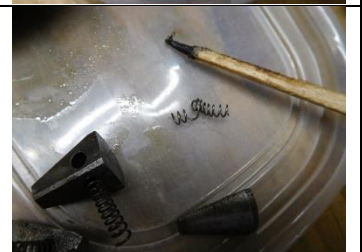
As you can see, one of the springs is stretched and bent out of shape. Accumulated dirt and/or rust in the bell housing can prevent the leaflets from moving together. Continued tightening can cause damage to one or more of the springs.

I did not have any replacement springs, so I elected to repair the stretched spring by wrapping it around a nail.

I used needle nose pliers to coax the spring back to its glory days. It got real close.

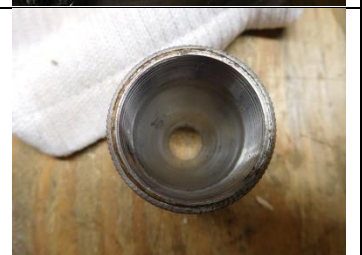
The chuck consists of several components. This is an inside view of the bell housing. Over time, it gets dirty and the leaflets cannot move freely. I cleaned out the inside of the bell housing and used fine sandpaper to remove a rust spot near the apex.

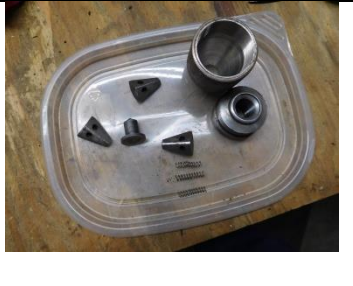
Here are the chuck components. When assembled, the leaflets are joined by springs and reside inside the bell housing, resting on a floating base. The floating base sits on the housing floor, which is screwed into the bell housing using the spanner service tool. As the chuck is screwed down the drill post, this whole assembly moves and the floating base advances inside the bell housing. The floating floor and the springs work together to keep the leaflets moving in unison. It is easy to see how this mechanism can be adversely affected by dirt and rust.

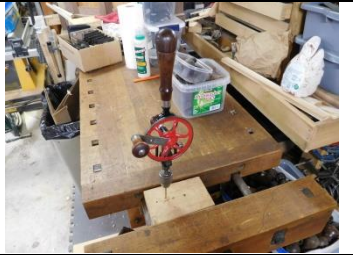
Here is the drill in action. Indeed, cordless is the way to go!
