Restoration of a Vintage N. Slater Woodworking Vise

August 2016

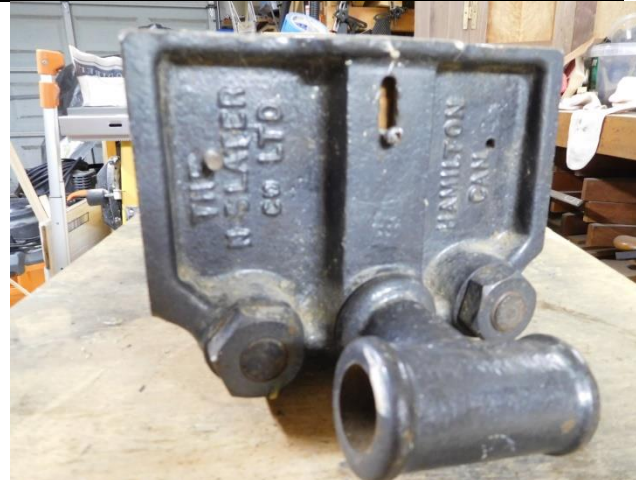
This vise is in pretty good shape and most of the original black paint is present. There are a few white paint splatters. There is almost no rust, so it probably lived in a climate controlled shop.

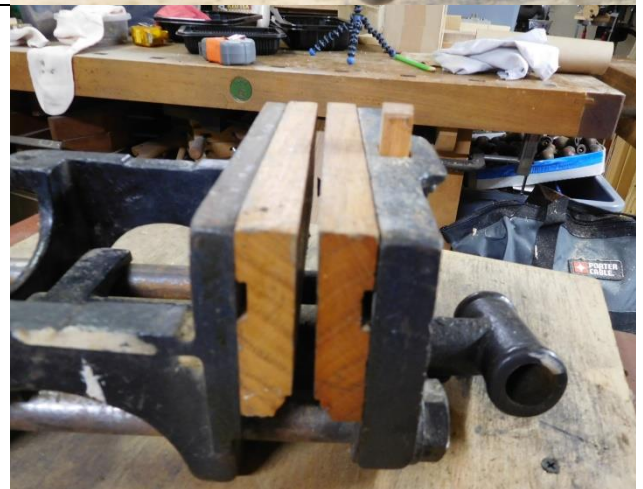
Two pieces of oak baseboard trim were used as vise jaws and the dog is a replacement probably made from the same supply of oak.

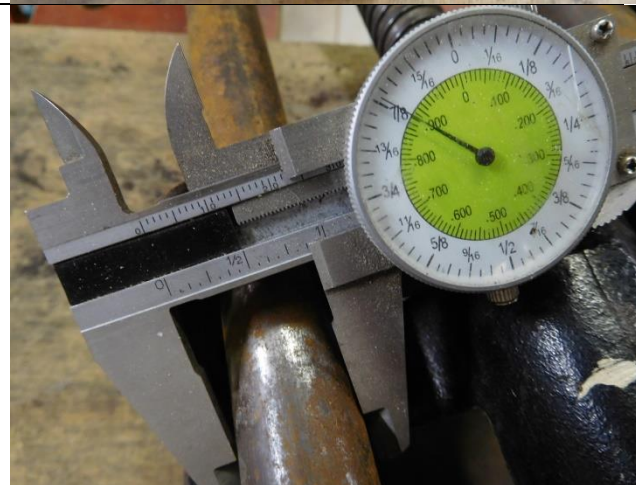
Wow! The guide rods are 7/8 inch round bar stock and are bolted to the front, or dynamic, jaw. This vise was made for heavy duty work.

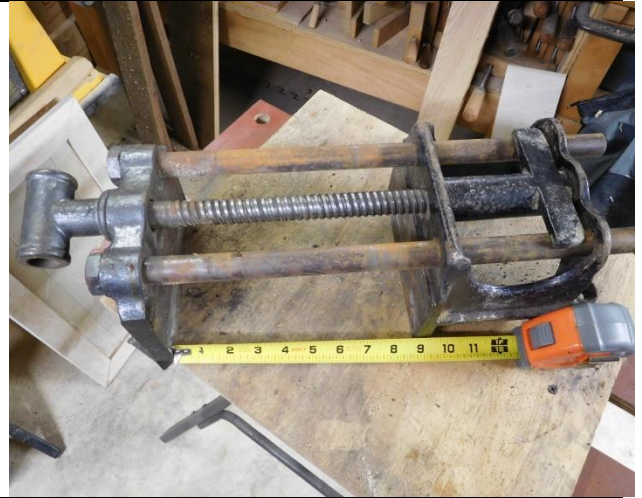
The dynamic front is 7 inches wide, so this is a 7 inch woodworkers vise. Most vises this size open to ten or more inches and I am surprised to see that the leadscrew falls out at 9 inches. The leadscrew also lacks smoothness. Something is not right.

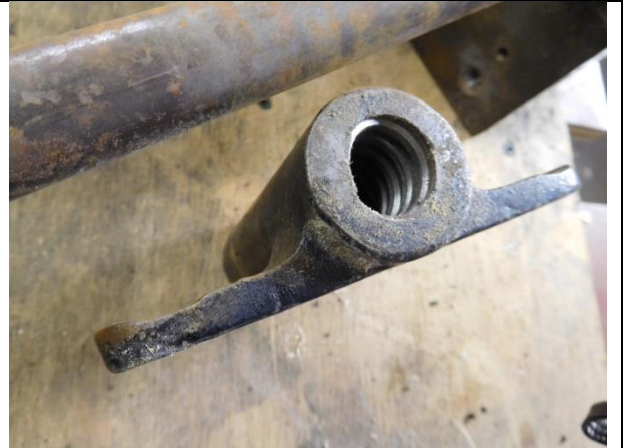
Woodworking vises generally have a cotter pin on one of the guide rods which is used as a stop. Once the vise is fully extended and the guide rod meets the end of the static face bearing, this pin prevents further extension. Of course, removing the pin allows disassembly of the vise. The nut housing is made like a "T". The cross piece rides on the guide bars for stability and also to prevent circular motion.

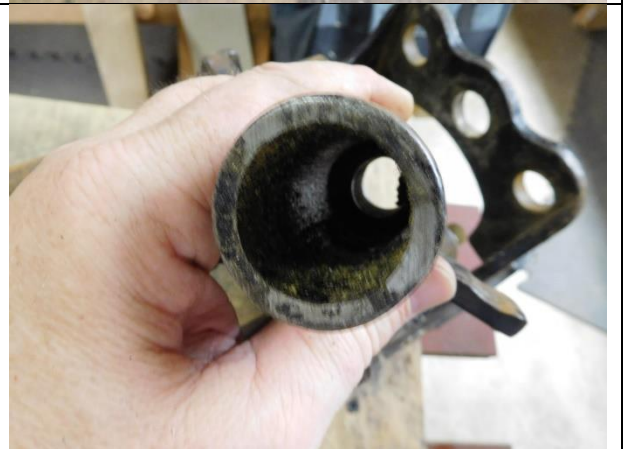
Removing the "T" nut shows immediately where our problem lies. At some point, this vise was disassembled and the "T" casting was inadvertently reversed. Yet another clue that this vise came from a school with novice woodworkers.

As you can see, the threads are extend a little over an inch into the end with the crossbar. The remaining of the housing is in place to protect the acme leadscrew. I orient it properly and replace the static jaw and cotter pins.

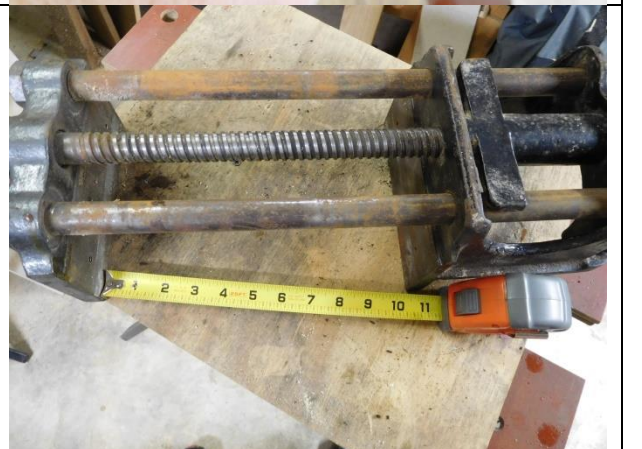
Once I reassemble the vise I am able to get the full 11 inches of extension. An added bonus is that the screw action goes from just OK to Cadillac, probably because the nut threads are better supported.

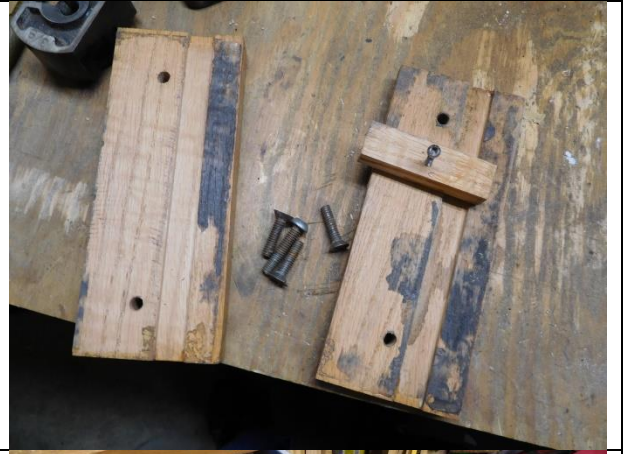
Here are the faces and the dog. Notice the odd bolts used to attach the faces. Our previous owner used suitable wood, oak, and trimmed the pieces accurately. But then he used bolts for attachment. My guess is that he was a novice woodworker who was tasked with making these jaws.

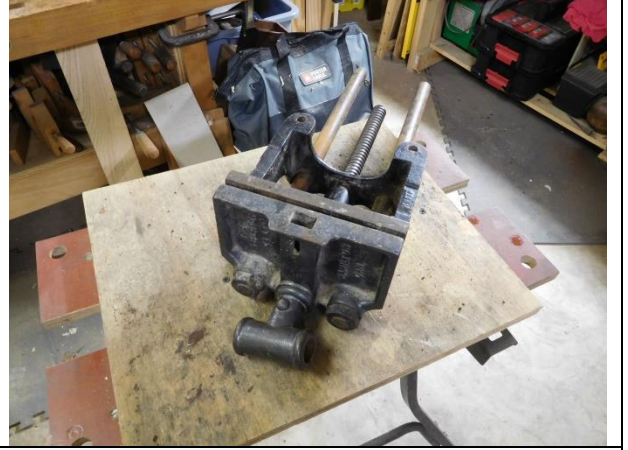
Here we have reached the end of phase I. The mechanical issues have been resolved, white paint spatters have been removed, and the unsightly baseboard trim faces have been removed. Time for a good cleaning.
