Restoration of a Vintage Reed Machinist Vise

August 2016

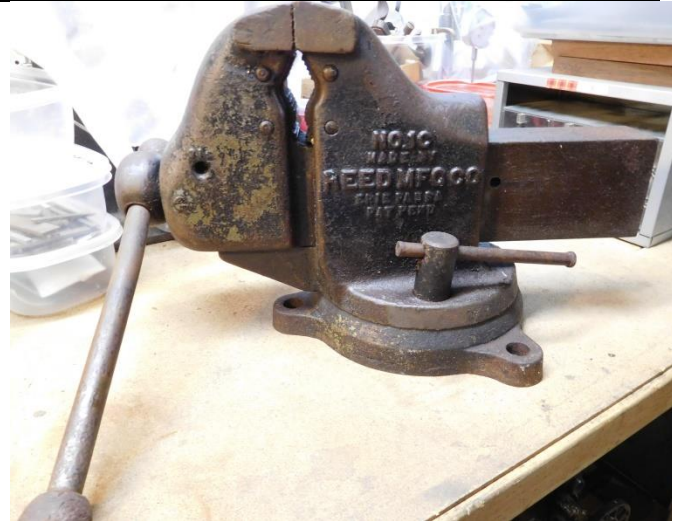
And here it is—a Reed model 1C. It has 3 ½” jaws and weighs a portly 54 pounds. Earlier models had a round ball handle. Those were made from about 1902 and up through the 1920s. The style pictured was made from around 1920 until the mid 1960s, during their so called “golden years” of quality. From the looks of it, I would date this particular vise to the early part of that period and no later than the 1930s. The paint, which seems to be original, reminds me of black asphaltum used on handplanes of the depression era.

The jaws of this vise were cut and hardened and then pressed into the cast iron while it was still cherry red.

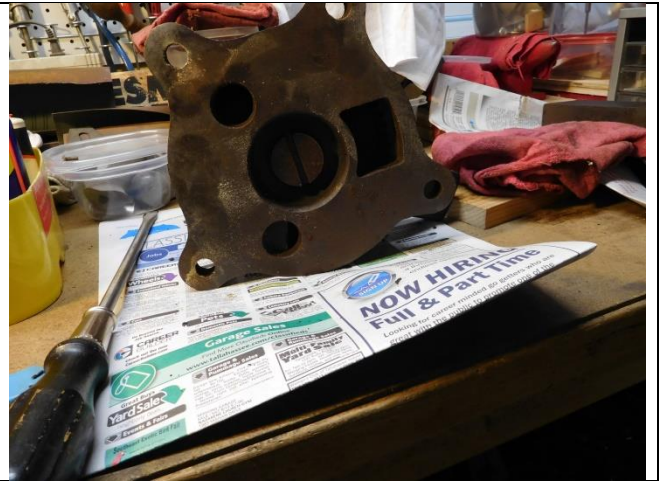
Well, maybe this one was 55 pounds if you include the thick coating of grease and gunk. And where am I going to find a screwdriver large enough for that screw?!?

Remember the base and that large flat screw? I tried to remove it using my largest screwdriver but had no luck. It was on pretty tight.

I have made plane blades and cutters for years, using flat ground stock of various thicknesses. I went over to the cutting area and found a scrap on the floor that was the proper thickness for this screw slot. I ground it flat and used my vise grips to improvise a screwdriver. The screw came out fine. It did need coaxing but my makeshift screwdriver did the trick.

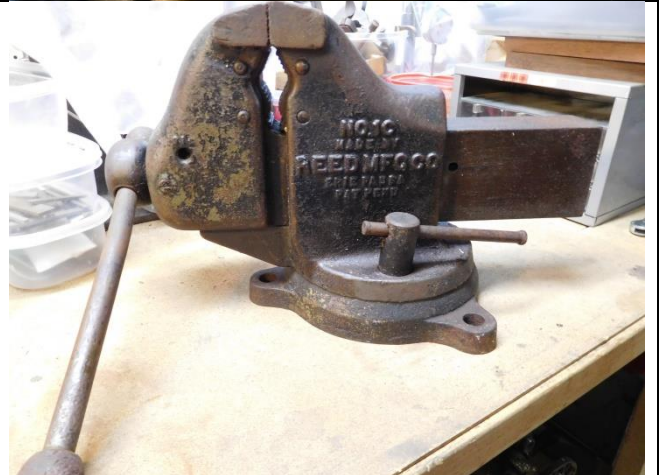
It is time to take out the leadscrew and handle. These vises have a unique method of disassembly and it helps to study the side view picture of the vise. On the front of the dynamic jaw you can see an oil hole. It even has the word "OIL" cast above it. (There is another oil hole on the rear of the slide. Look in the same picture just to the right of the cast "Co". That oil hole is for the acme leadscrew). From the oil hole, at the 8 o'clock position, you can see a wart. The wart in the picture is actually a set screw which holds the clamp for the leadscrew and handle assembly.

Begin by fully extending the dynamic jaw and removing the whole assembly. Next you remove the set screw. Remove that setscrew, pull on the handle and you will see four divots equally placed on an outer ring. Put a punch or awl on one of these divots and move it counterclockwise. The ring should move. Keep unscrewing until it comes off. It is a split ring and will come off in two pieces. Once it is removed, you can pull out the handle and leadscrew. The handle has a washer on its end.

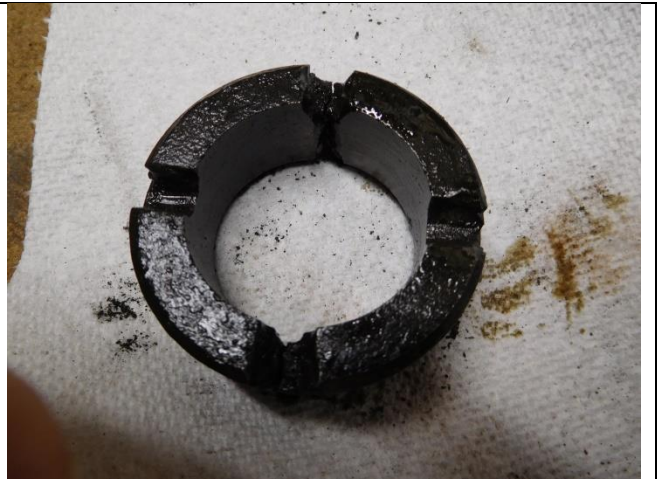
Here is the split retaining ring that secures the leadscrew and handle.

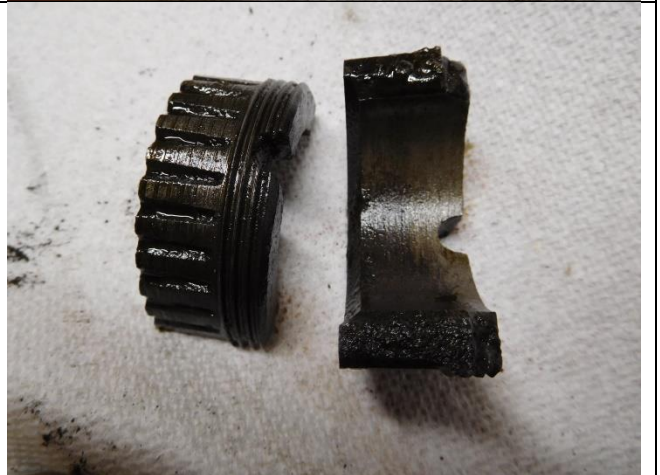
Here are the two halves. No, it is not broken; it was made that way to fit between two larger pieces.

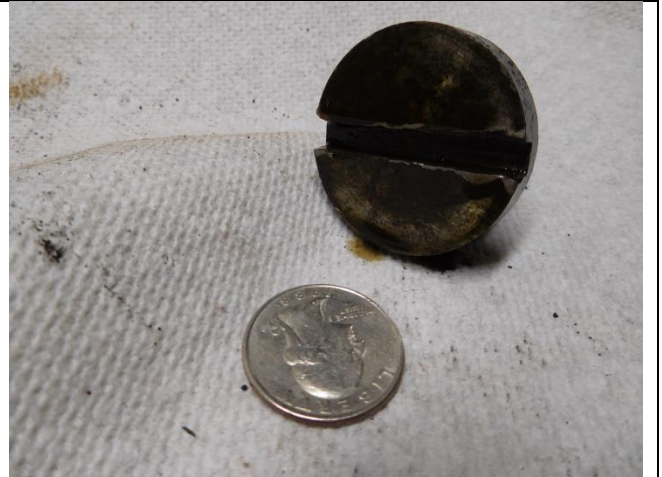
Here is a close up of the screw. It is larger than my flathead screwdrivers. As you can see, it is even larger in diameter than the quarter. The head was boogered up from previous hamfisted attempts to remove it using improper tools. I filed down the offending metal.

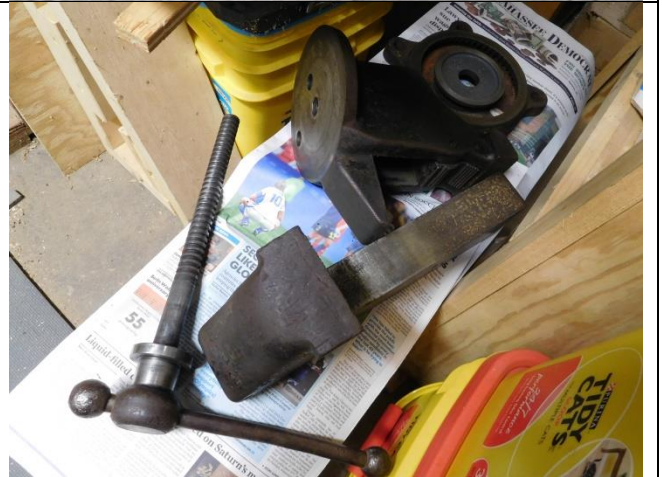
Here is a shot of the clean leadscrew, dynamic, static jaw and the base.

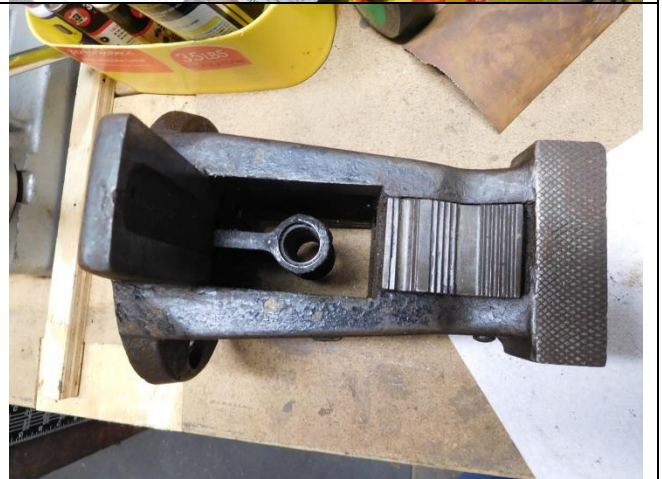
Here is a picture of the leadscrew nut. It is held in a dovetail slot by a split nut. And by rust, I might add. I have been trying to persuade it out by using a plywood stick and mallet. No dice. It is not going to budge. Since there is no real reason to remove it, I will let it stay in place where it is happy.

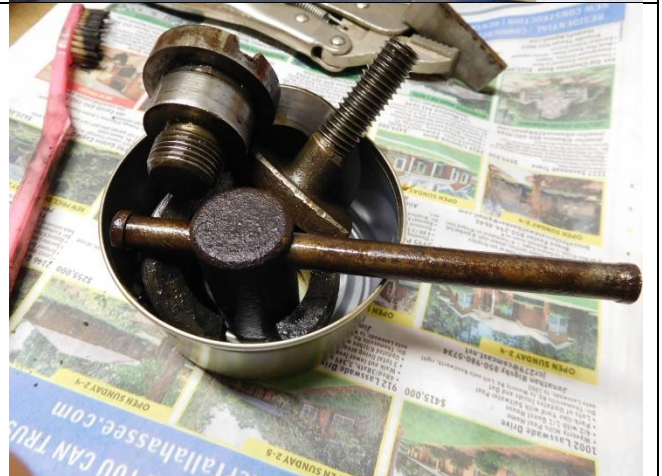
Here are the miscellaneous parts, soaking in a tuna fish can after cleaning. I bathed them in 3 in 1 oil to prevent rust.

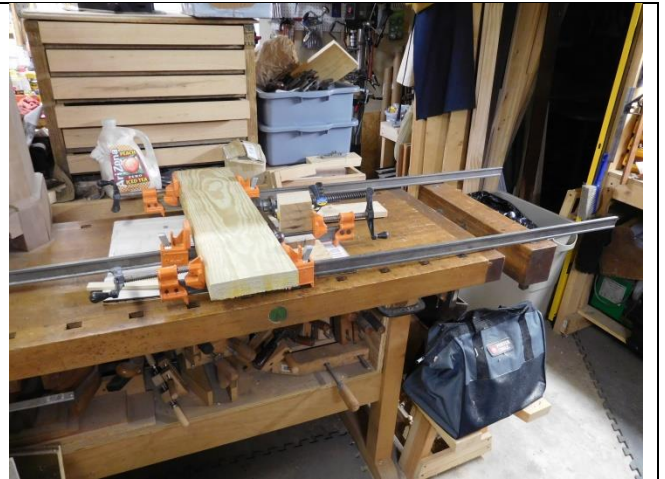
One of the items to address is the double kink in the vise handle. It was abused at some point and the handle is kinked enough to prevent it from sliding properly.

Vise handles are soft and can be bent using cold forming techniques. That generally means to use cauls and a shop frame press. I do not have a press but I do have a generous stash of woodworking clamps. Some of these clamps are substantial, like these Jorgensen 48" I-beam clamps. I used them along with a pressure treated lumber scrap to make a redneck press. Here is the setup.

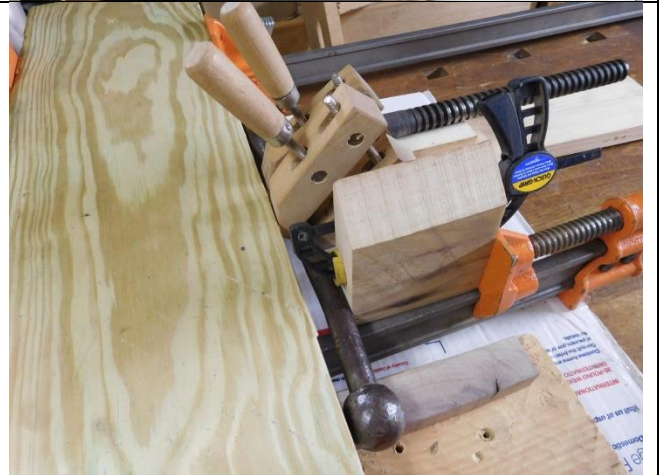
Here it is in action. The smaller clamps are just keeping things from twisting. I am using a stout piece of walnut end grain as a forcing caul. The ball of the handle is protected by the pressure treated base.

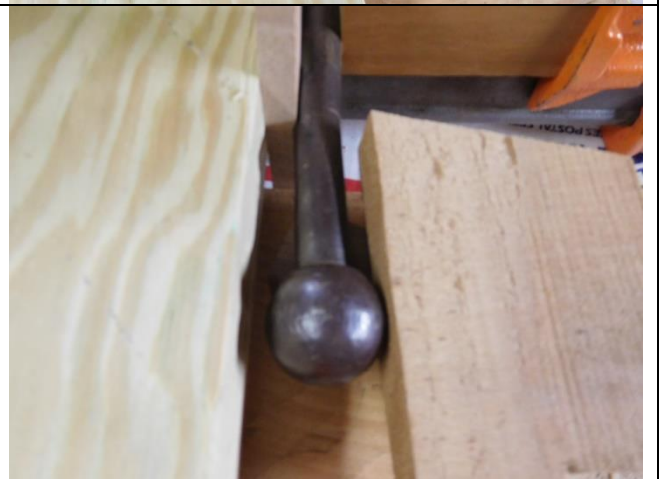
Here is a picture as the operation continues. One of the kinks is gone and there is one to go.

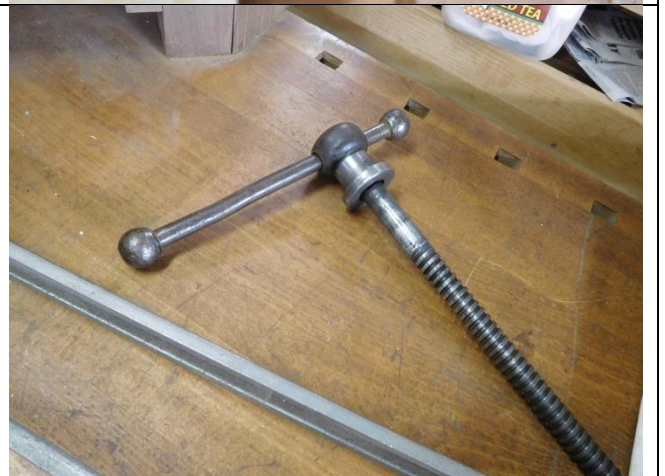
It took about twenty minutes of grunting and bending to tame those kinks. Here is the final result. There is still a slight deformity but the handle slides well. I will leave the slight defect as "charm" and as a badge of courage on a tool that has had a long and productive life.

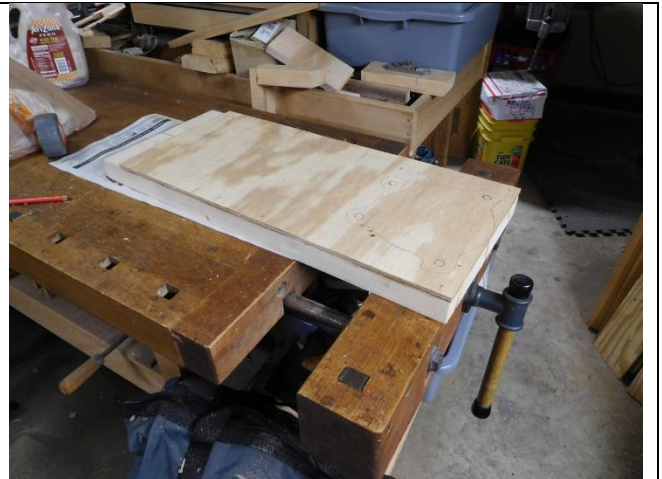
For this vise, I glued up two sections of 2x6 construction lumber and added a 1/4" piece of plywood to the top.

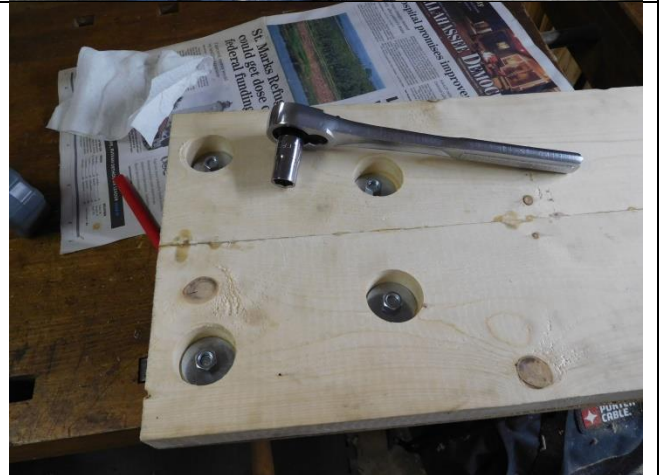
I drilled holes for the base and countersunk the washers.

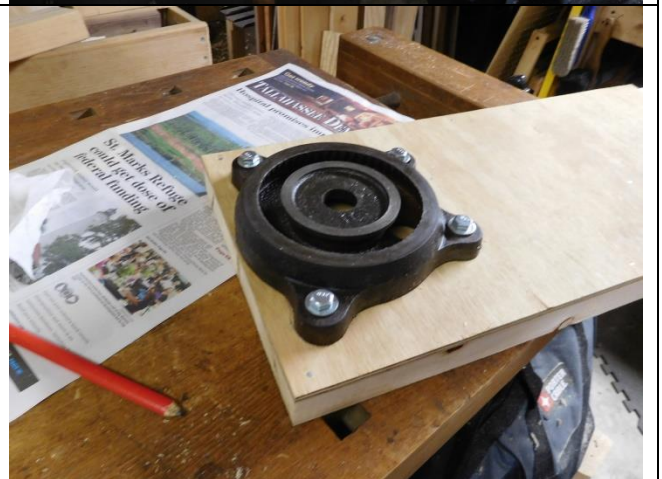
The base is mounted but can you spot the issue? Look carefully.

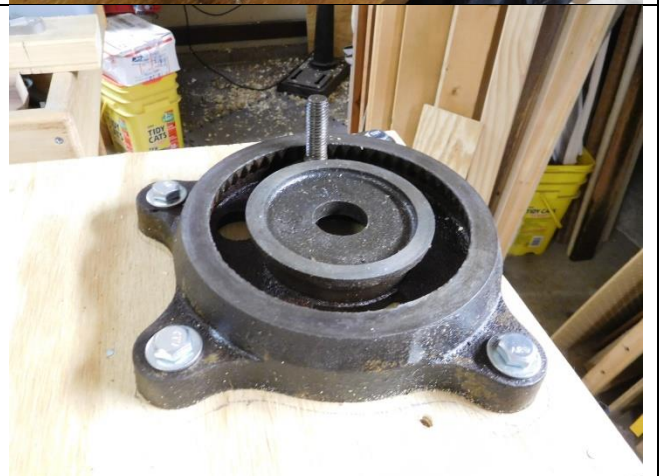
Of course my eagle eyed readers noticed the flaw immediately. In my defense, the workshop is oppressively hot. After all, this is north Florida in August. In my haste, I mounted the base and forgot to insert the swivel bolt. In this picture you can see the hole on the BOTTOM where it is inserted.

So I had to remove ALL of the mounting bolts in order to insert the swivel bolt. It was not a big deal except I had to get out the socket wrench set and redo everything. It was just an opportunity to have some more shop fun.

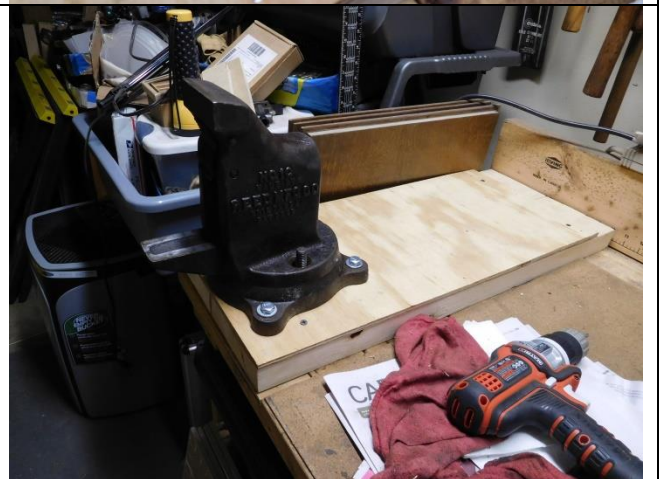
Early examples have raised lettering cast into the metal. It is easy to highlight the castings with contrasting paint. I used white paint and a makeup sponge.

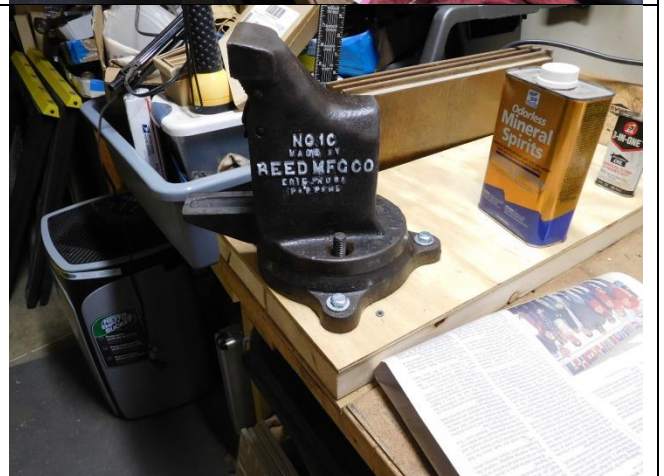
Here is the final result.

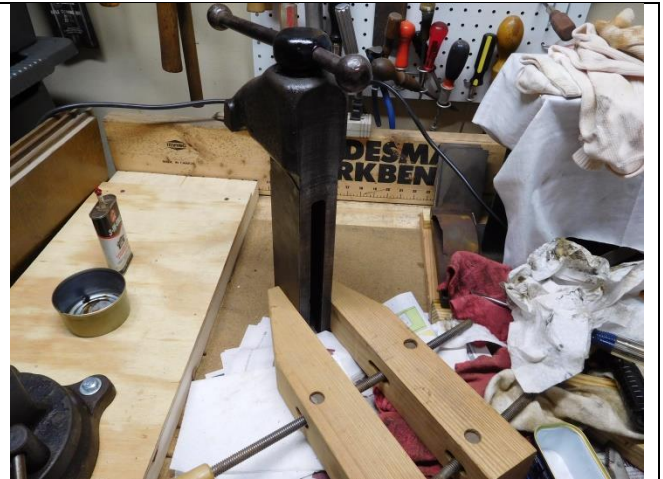
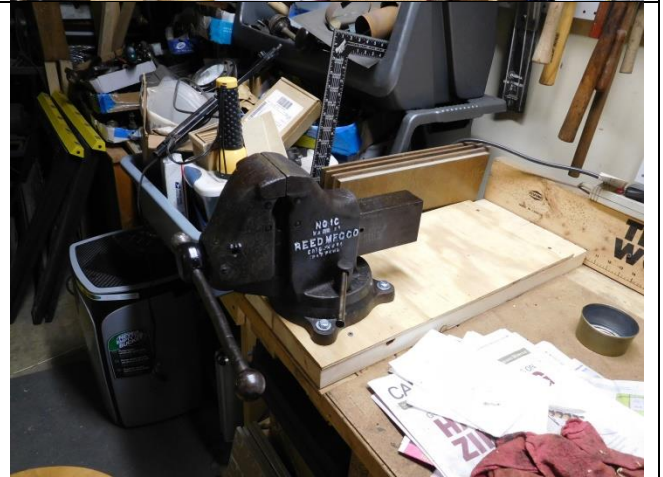
Here is the money shot of the Reed 1C vise mounted in place. It had most of its original black japan finish so I kept it in place. I cleaned everything up and oiled what needed to be oiled. Other parts were coated with BLO (75% boiled linseed oil and 25% turpentine). The BLO provides a protective coating to cast iron and works much like the seasoning on grandmother's black skillet.

I carefully taped the handle and painted the nose black because it had lost most of its original finish. The new paint blends in well because the nose is a small isolated spot.
