## Restoration of an Athol 624 ½ Machinist Vise

August 2016

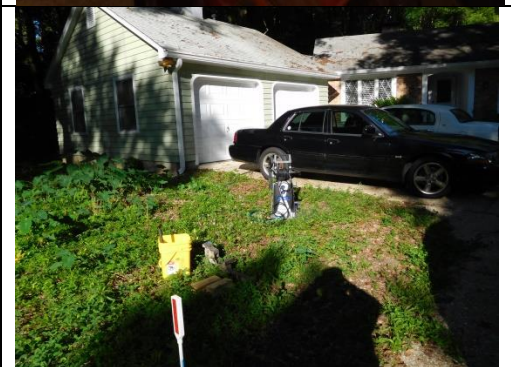
I used some pressure treated post cut offs to keep things off the dirt. Never throw away cutoffs. You never know when they will come in handy. Here is the greasy leadscrew ready for a spritz.

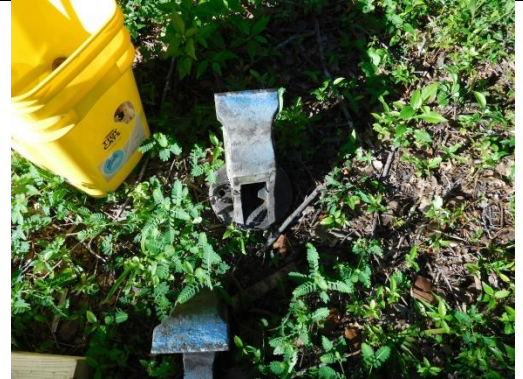
Here is the static base getting clean. The silver paint came off to reveal a blue base.

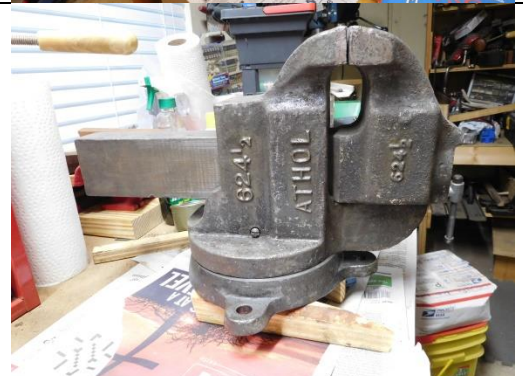
I mocked up the vise parts for some progress shots. I wiped them with Simple Green to remove more grease. I have been scraping the large surfaces with a pocket knife and have been using a Dremel tool with a brass brush to clean out the detail areas.

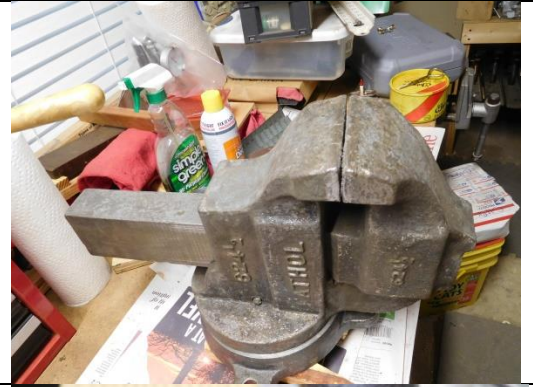
There were a few small casting defects and I ground them off with a grinding wheel in the Dremel.

Once the base was clean, I brushed it with BLO and set it aside to dry. It will get a coat of Rustoleum primer next week.

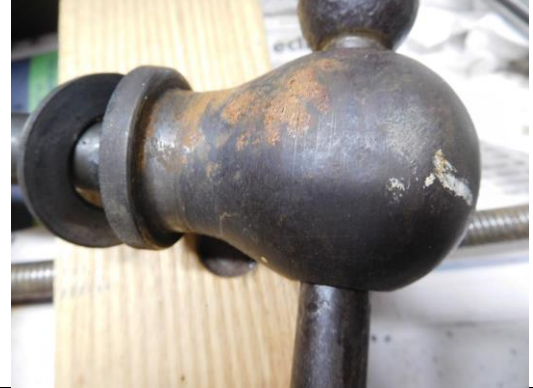
The leadscrew is dirty but in nice condition otherwise. It just needs a little cleaning and polishing.

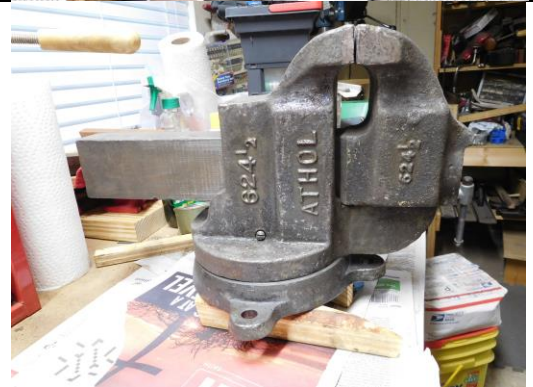
Meanwhile, the vise body has been stripped and is ready for a coat of BLO (Boiled Linseed Oil and turpentine). I use a 75-25 mixture and apply it with a brush. After it soaks in for a few hours, I wipe off the residue. Blo seals the porous cast iron and keeps it from rusting.

It takes about a week to fully dry. After that time, the vise is ready for use or for painting.

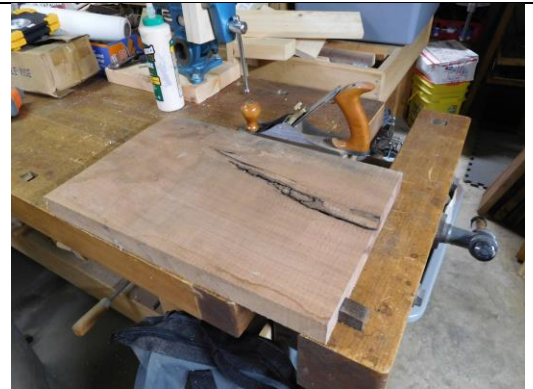
This 6/4 walnut is rough and needs a little help from the handplanes.

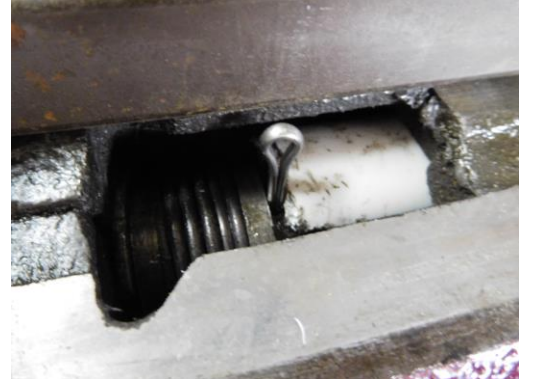
Here is a picture of the cotter pin in place. It cannot be driven home because the exit hole is covered by the washer.

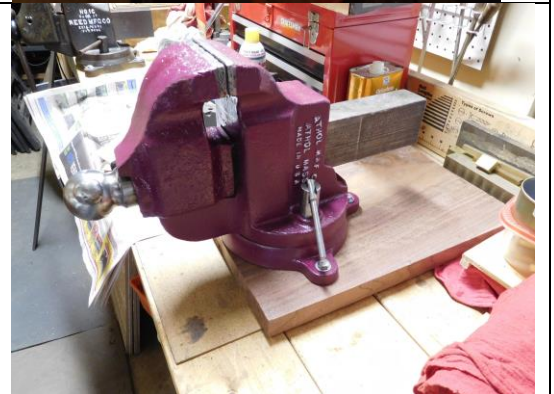
The cleanup began with the pressure washer and finished with some bright purple paint.
