Restoration of a Charles Parker 102-3 Bench Vise

August 2016

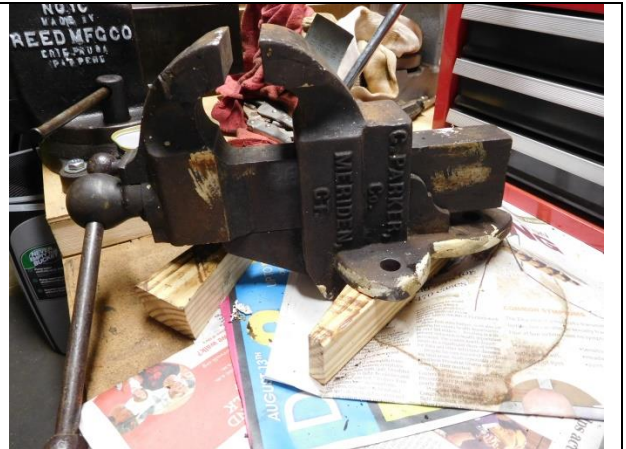
Here is a picture of the vise when it arrived. It has splashes of white paint but is in great mechanical condition. The action is very smooth.

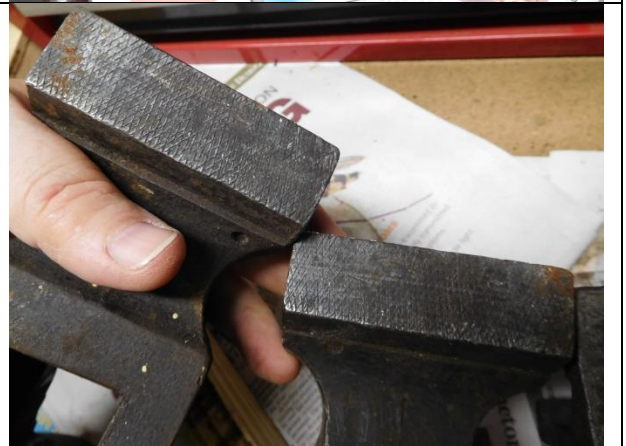
Although somewhat worn, the jaws are in really good shape. This vise will be a great user.

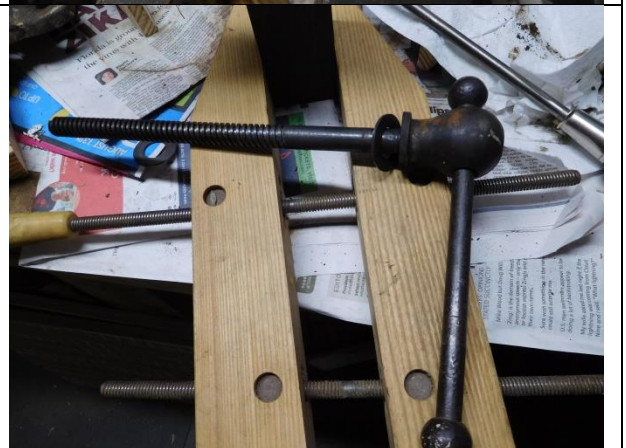
The leadscrew is in good condition and the handle is straight. No one abused this vise.

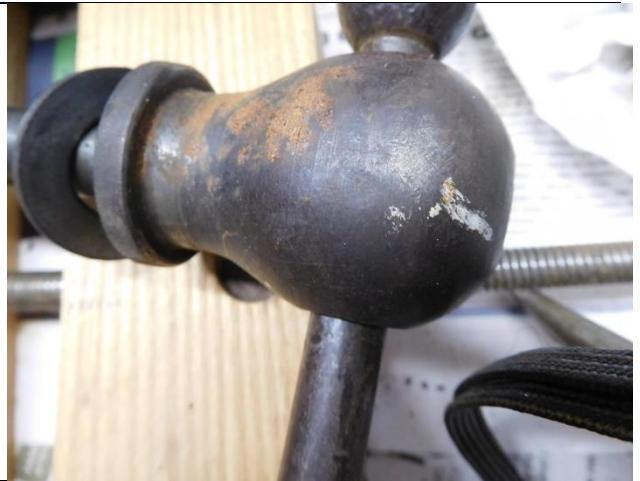
The nose of the leadscrew needs a little attention. A visit to the wire wheel will make it happier.

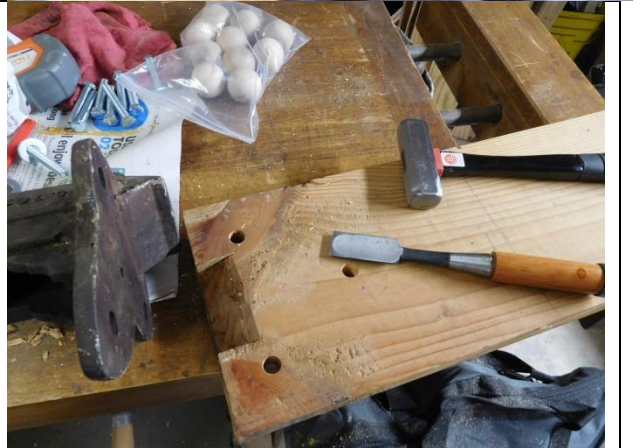
I made a bench mount out of some recycled heart pine which has some history. These boards are probably 75 years old and were originally shelving in my grandfather's woodshop. W.C. Reed was superintendent of schools in Eagle Lake, Texan, but was also a woodworker. My dad and I recovered these boards from his workshop and also used them as shelves. I slapped two of them together and made a nice mount. I hope Granddaddy Reed would find pleasure knowing that he helped me outfit my shop.

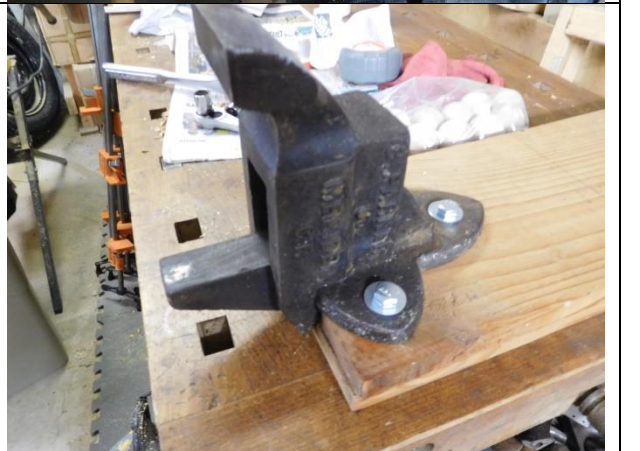
The vise mount does require a little work. You can see the beveled base projection. The front floor projection of the static jaw receives much stress and punishment and this extra iron provides strength.

I made two saw cuts and used a wide Japanese chisel to cut the bevel. Those chisels take lots of pounding from the metal hammer, but they work quickly. This wood cut easily, even with the knots. Ten minutes of hammering gave me a perfect bevel

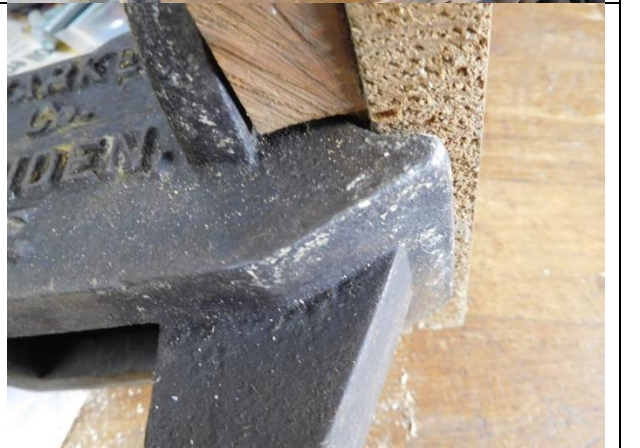
I could have mounted the vise forward, but mounting it rearward has advantages. This allows the mount to take some of the stress from the static. It also moves the mounting holes further back and makes them less prone to pulling out.

Here is a picture of the underside. Our notch is perfectly sized.

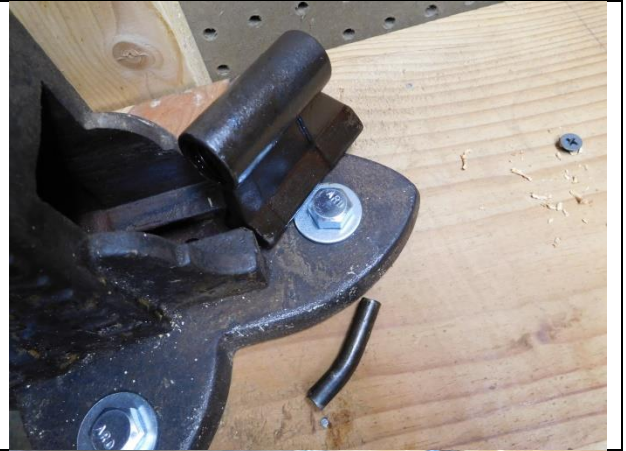
Unfortunately, the perfection does not apply to the vise mounting. It is common construction on vises of this era to have a leadscrew nut which sits in a dovetail. I removed this nut to clean it and also to clean the female dovetail slot. Here is the nut and the bent pin which holds it in place.

Notice the small sheetrock screw at the far right. Yes, the mount is attached to the workbench.

BUT the nut will not fit in the slot unless the rear bolt is removed. AND the bolt cannot be removed unless the whole mounting bracket is REMOVED from the workbench.

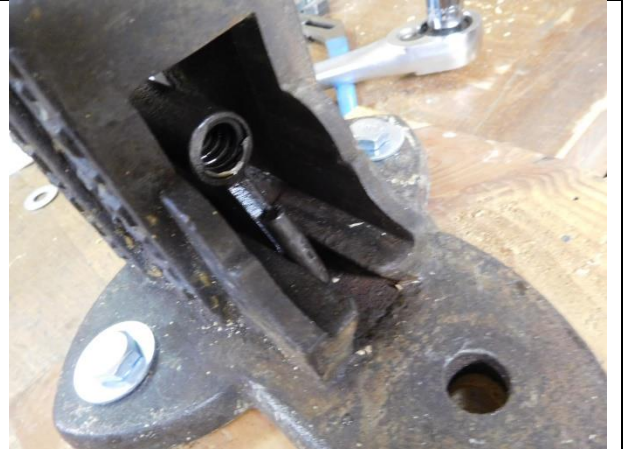
Finally. The mounting bolt is removed, the base nut is replaced and pin is inserted.

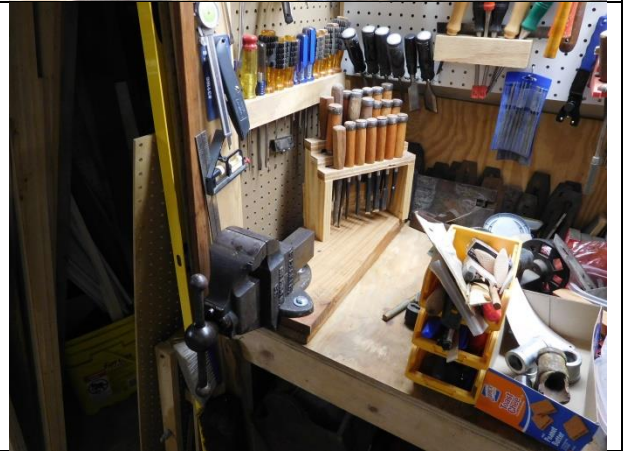
And here is the vise in its new home. It is quite fitting that its neighbors are the Japanese chisels that helped with the base.

There are too many projects in the shop right now. In addition, the shop is oppressively hot. This quick clean up will have to do for now as this vise is put into action. Sadly, this little vise will have to wait for a more comprehensive restoration.
